MDF Door Cycle Slam Report

NRRI Technical Note TN-2007/30
December 2007
Project 187-2419

Prepared for: IHS Door Company
1505 8th Street
Superior, WI 54880

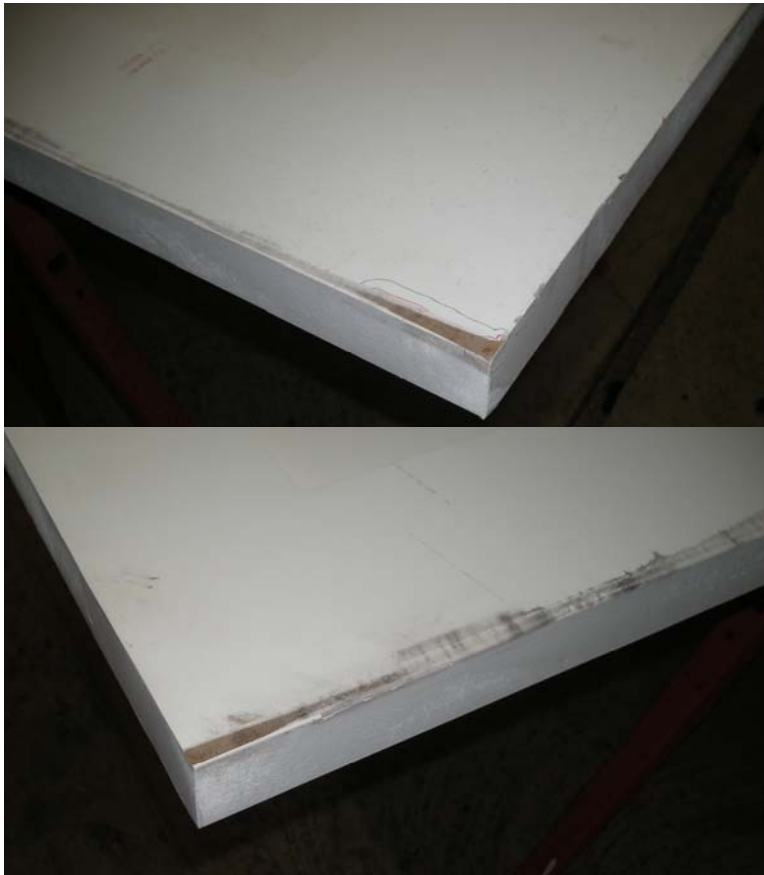
1. The door shows no visually apparent damage after 500,000 (+) cycles.
2. The door shows no wear that would inhibit functionality.
3. Screws in one hinge would loosen slightly and needed to be tightened.
4. Some paint cracks were noted during testing at the joint of the insert panel to the stile and rail, but they appear to be unrelated to the cycle slam testing.

Figure 6.--Paint wear that occurred during the testing.

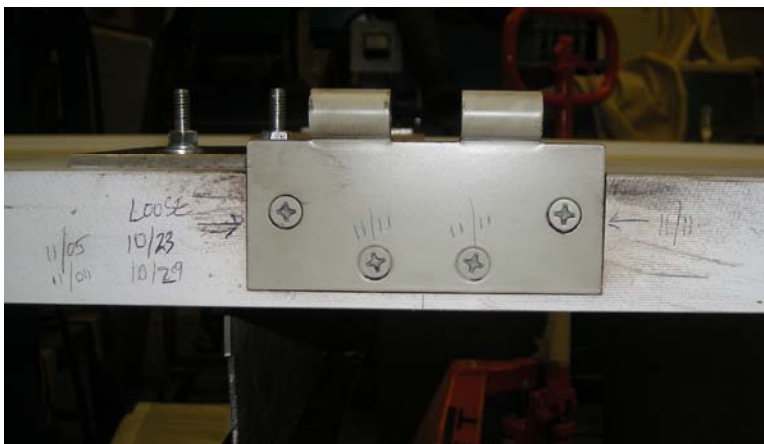
Figure 7.--Loose screws noted on one hinge during the testing.
